# Marrek Pond Dam Removal and Restoration

## History and Background

After heavy rains in 2015, water breached the dam and caused major damage to the structure. Cleveland Metroparks received a grant from Ohio EPA to remove the dam and restore the natural flow of the tributary by reestablishing the stream channel and restoring the surrounding wetland.

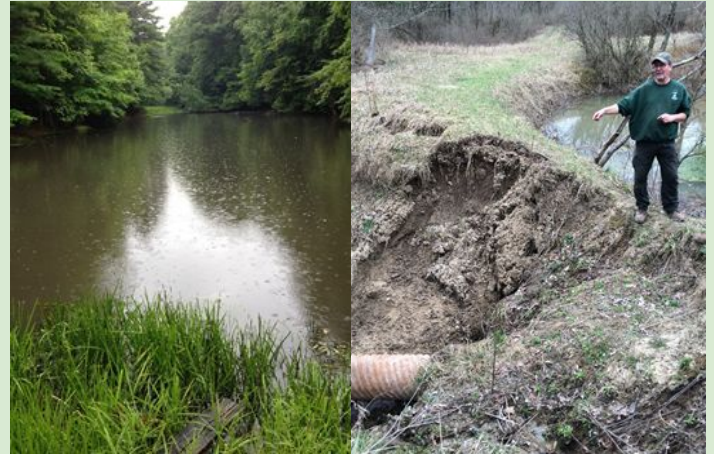
Left: Marrek Pond before dam failure.  
Right: Dam after failure.

The Marrek Pond project was comprised of two main parts: removing the artificial dam, and reestablishing stream and wetland habitats.

The dam removal eliminated barriers to aquatic animal migration and restored the area's natural hydrology. Metroparks staff was careful to conserve existing natural resources at Marrek. The existing game fish in Marrek Pond were relocated before construction crews removed the dam and drained the pond.

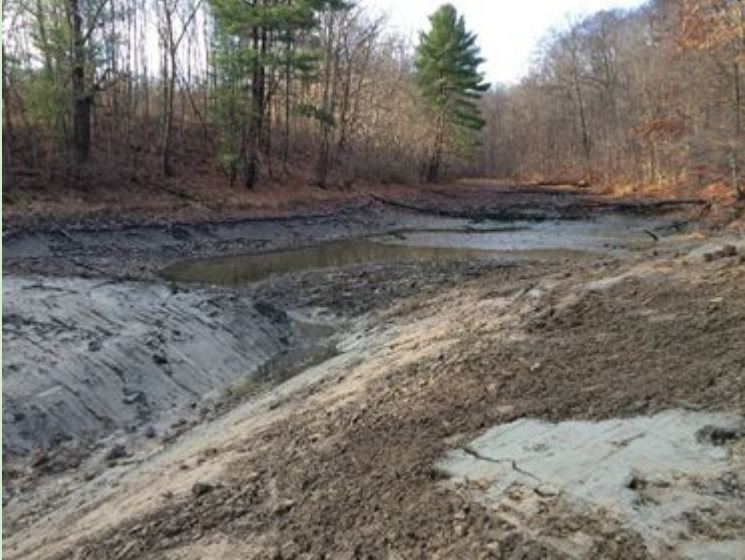
Marrek Pond after drainage in 2016

Game fish population was transferred from the pond in October and in December the pond was drained.

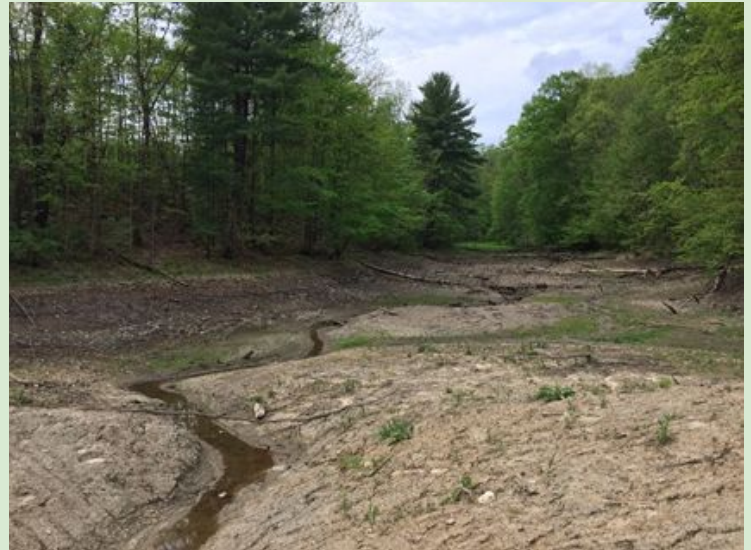
Project site after stream channel is reestablished in 2017

Following the dam removal a stream was created through the former pond bed. This included the construction of a meandering stream channel and riffle habitat. Regrading the stream channel allowed water flow to access the surrounding floodplain which created additional wetland habitat as well as enhancing the existing wetland. Live stakes and log grade control structures were added to stabilize the soil and limit erosion. Trees, shrubs, and native grasses were planted on site to promote a healthier, vegetated floodplain.

Native woody species were planted along the stream bank and log grade control structures were installed in the stream.

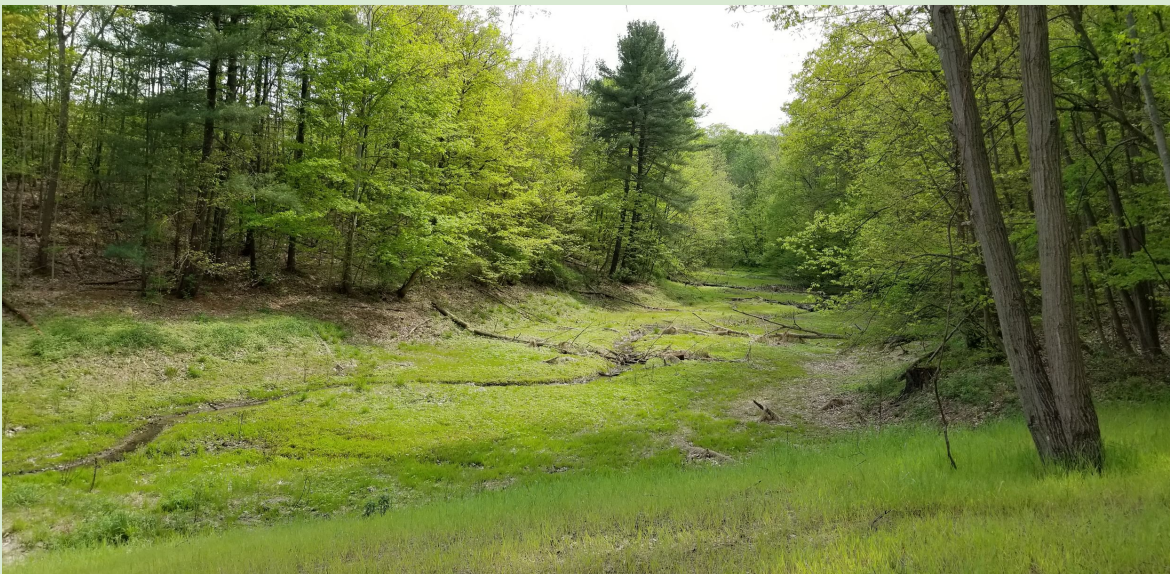
Restored project site in Spring of 2019

Last of the planned log grade control structures were installed and woody plants were added to the riparian zone.

The restored stream and wetland will contribute to the health of the Hinckley Lake watershed. Along with improved hydrologic functionality, the new habitat will promote wildlife in the area and add to the experience of visitors to Hinckley Reservation for years to come.
